# BELZONA SUPERWRAP II SEALS DETERIORATED PIPE COUPLING

ID: 7912

Flange coupling connecting a 32" cooling water bypass line for the power plants cooling tower.

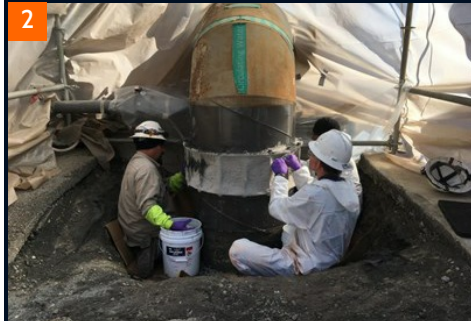
The pipe coupling was buried and therefore suffered severe corrosion below the ground.

1. Damaged coupling.
2. Application of Belzona 4141.
3. Application of Belzona Superwrap II.
4. Complete Application: Before & After
