# PRIMARY CRUSHER BASE REPAIRED WITH BELZONA 4111 AND BELZONA 4151

ID: 7914

Base of a primary crusher at a mine.

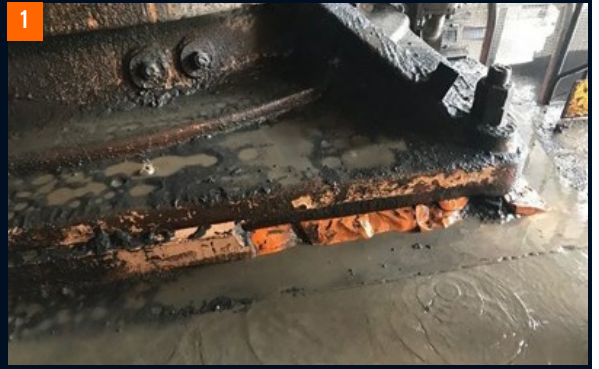
Excessive vibration of the crusher caused the concrete base to crack which could potentially compromise the functionality of the machinery.

Damaged base of the crusher. The perimeter of the base rebuilt with a regular mix of Belzona 4111. A fluid mixture of Belzona 4111 and Belzona 4151 resin used to fill in the void and have it self-level in the base. Foundation of primary crusher repaired with Belzona 4111 and Belzona 4151

Using an impact hammer drill, the first two layers of concrete were removed to reach the steel reinforcement structure. Prior to application of Belzona 4911 (Magma TX Conditioner), area was cleaned and degreased with a solvent, compressed air was also used to have the entire repair area free of loose debris and dust. The perimeter of the repair area was rebuilt with a regular mix of Belzona 4111, and after that, a fluid mix of Belzona 4111 with extra Belzona 4151 was used to fill the void and self-level the base of the equipment.
