# BELZONA REBUILDS THE SHREDDER HOUSING LID

ID: 7916

Fruit Processing Plant, South Africa

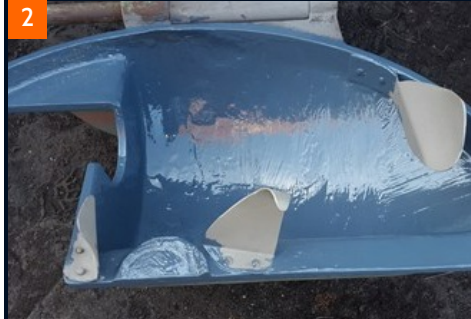
Hard mango pips were dimpling the shredder housing lid. Eventually, oversized pieces of Atchar were being caught up in the filtering screens.

1. Damaged lid
2. Lid protected with Belzona
3. Bottom dome prior to application
4. Dome protected with Belzona

Application was completed in accordance with Belzona Know-How System leaflet CEP-3. The lid and the bottom dome have been grit blasted in preparation for the coating. Then, Belzona 1321 was applied as a two-coat system. The whole application took 4 hours to complete at a fraction of the cost, comparing to the purchase and installation of the new 316 ss apparatus.
