# BELZONA PROVIDES LEVEL SURFACE ON A WALKING FLOOR

ID: 7919

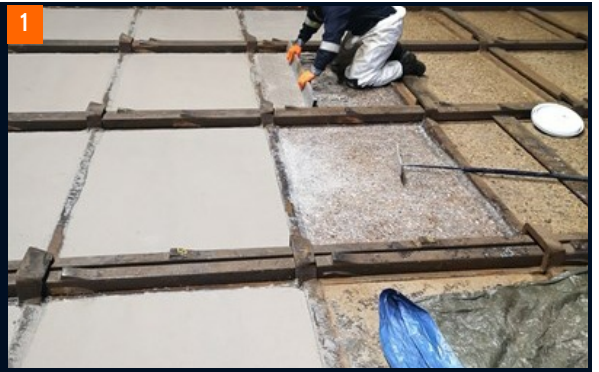
- 1- Application of the test area of Belzona 4131
- 2 - Completed Trial Application
- 3 - Completed Trial Application (2nd View)
- 4 - Completed full repair.

The Belzona 4131 system was applied using the existing channel rails as a datum for depth and finish. The average depth was estimated to be 18mm. This application was completed in accordance with Belzona Know-How System Leaflet FPA-01.
