# BELZONA REPAIRS VIBRATION DAMAGE IN A SLACKER CHUTE

ID: 7920

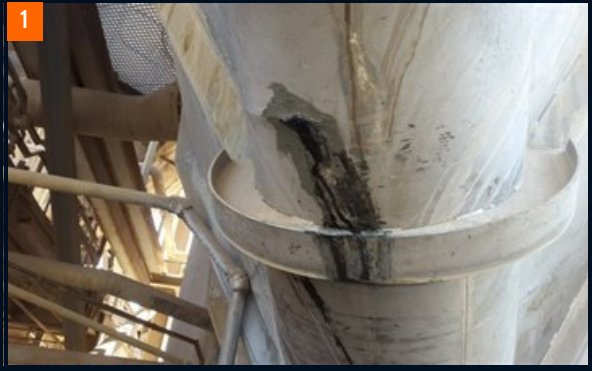
Due to an increase in the plant's production, a new slacker chute was installed in 2015. During the chute's operation, there would be intermittent vibration causing bearing wear. It also resulted in the screw flights coming into contact with the shoot body on the preload and discharge sides, thinning out the stainless steel.

1. Through-wall defect on slacker chute
2. Steel patch bonded into place
3. Belzona 1111 also used to seal a deteriorated drain valve
4. All repairs coated with Belzona 1341 for additional protection

The application was carried out in accordance with Belzona System Leaflet VPF-1. At the top of the chute, a through-wall defect had emerged. A 3mm-thick stainless steel plate was rolled to shape and bonded in place over the defect using Belzona 1111 (Super Metal). This was supported by a metal pole to keep the plate in place during cure. In addition, a drain valve at the bottom of the shoot had developed a through-wall defect. This was repaired also using paste-grade Belzona 1111. Finally, both repairs were then fully encapsulated with Belzona 1341 (Supermetalglide).
