# BELZONA PROTECTS BRAND NEW FERTILIZER PLANT

Brand new granulating plant in a fertilizer factory containing 98% sulfuric acid.

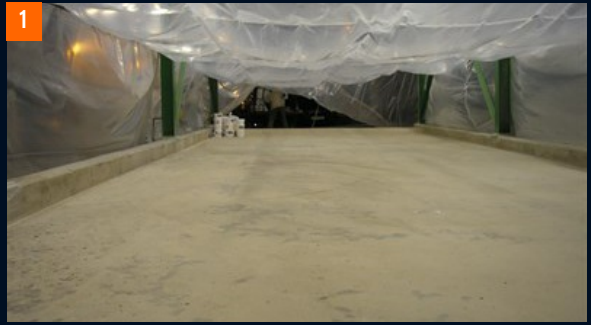
1. Application area being tented out
2. Belzona 4311 after being applied
3. Coated fertiliser plant area
4. Wear pads and flooring system 8 years later

Application was carried out in accordance with Belzona Know-How system Leaflets TCC-15 and TCC-08. The outside area was tented out and the new concrete was coated with Belzona 4311. A special mortar mix of Belzona 4151 and AL203 ceramic aggregate was made for the 2 pads for the tractors feet to rest on, yellow tinted Belzona 4151 safety lines were also applied to help the driver park the tractor easily.

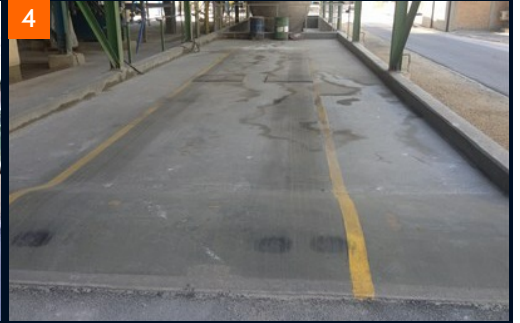
Over the years it was found that when the tractor picked up the tanker it would push it 10-20 cm backwards, damaging the Belzona 4311 coating with it's metal feet. To prevent this 2 wear pads were mixed and applied. 8 years later and the system is still in good condition.
