# BELZONA PROVIDES EROSION PROTECTION ON EXHAUST FAN

ID: 7929

Eroded fan blades at a cement plant.

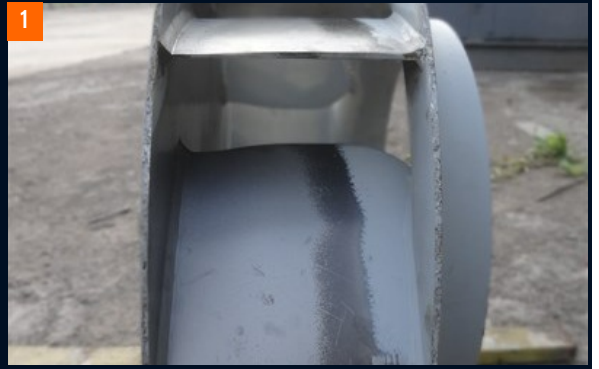
The dry air (70 °C) carrying Al, Si, MgO, CaO dust erodes the vanes of the fan blades, removing 2.5-3 mm of thickness from the metal.

1. The eroded fan
2. The fan after surface preparation
3. The leading faces of the fan blades rebuilt with Belzona 1812
4. The leading faces of the fan blades coated with Belzona 1321
