# BELZONA REPAIRS CEMENT PLANTS ROTARY DRYER

ID: 7930

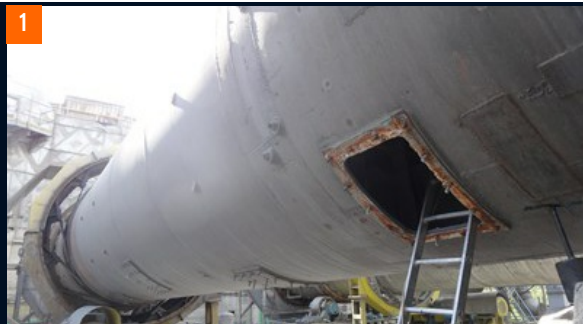
1. Entrance to the dryer
2. The view of the eroded area
3. The eroded areas rebuilt with Belzona 1811
