# BELZONA STOPS STRESS CORROSION CRACKING

ID: 7932

Production facility of an Oil & Gas company

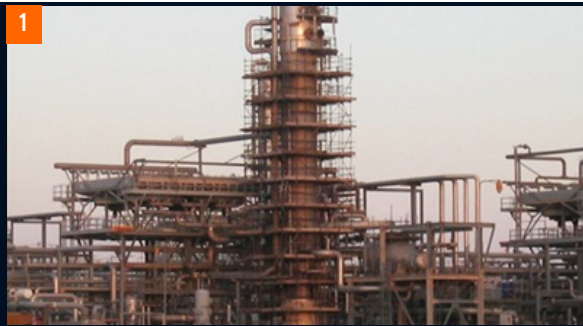
The column was suffering from dozens of cracks due to stress corrosion cracking (SCC) and some of them were leaking.

- 1 - The site
- 2 - The cracking
- 3 - The completed Belzona 1591

Belzona 1591 was applied over the cracked areas to eliminate further cracks formation and Belzona 1111 was used to repair the leaking cracks from outside. Copper wire brush was the only suitable surface preparation tool due to the presence of flammable material. This application was completed in accordance with a modified version of Belzona System Leaflet TCC-01.

Hot work was not an option due to flammable material inside the column and the large number of cracks. The plan was to replace the column after 6-8 months but Belzona's performance was exceptional. It stopped the leakage and no further SCC was observed. The column is still in operation after 5 years.
