# BELZONA OPTIMIZES THE EFFICIENCY OF A DISTRIBUTION CHAMBER

ID: 7958

Steel and concrete surfaces of a distribution chamber.

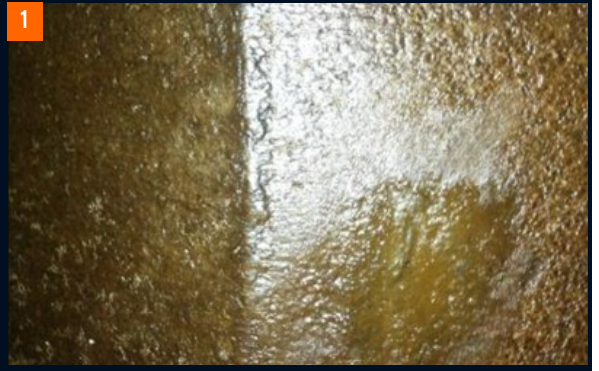
Due to an important flowrate of water from the river nearby, the surface of this distribution chamber, which had not been protected before, was badly damaged and needed to be rebuilt. The sharp angles of the concrete inside the chamber cause a resistance to the water flow, besides, the steel surface is badly corroded.

- 1- Sharp angle on the concrete
- 2- Reconstruction of concrete
- 3- Application of Belzona 1341
- 4- Final application
