# BELZONA CREATES POSITIVE GRIP ON RUBBER CLAD CONVEYOR DRIVE ROLL

ID: 7965

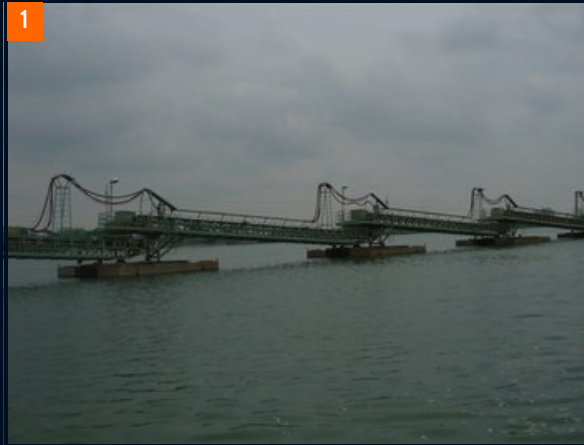
1. Floating conveyor systems used for transporting gravel
2. Worn out rubber cladding
3. Preparing for the installation of Belzona 2111
4. Fully applied system

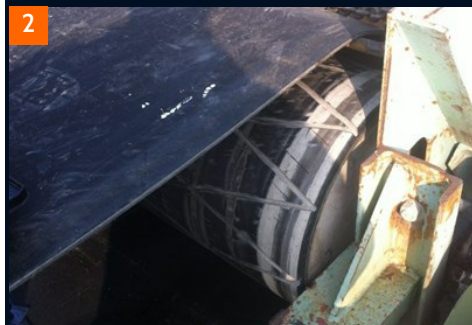
Worn rubber cladding was allowing belt slippage on a floating conveyor system used for transporting gravel. Whenever it happened on one of the rollers, the whole system would stop and it takes 30 minutes to restart it back to operating at full service. In rainy periods of the year this happens often and it is a significant loss of production time. Customer should also have spare rollers in stock ready for immediate installation.

Anti-slip chevron strips were applied directly onto an existing worn rubber lining of a conveyor drive roller. This was done without removing the lining and without dismantling the roller.
