# BELZONA RECONSTRUCTS THE COVER AND FLANGE OF A HEAT EXCHANGER

Cover and flange of a heat exchanger

Petrochemical Plant, Gabon

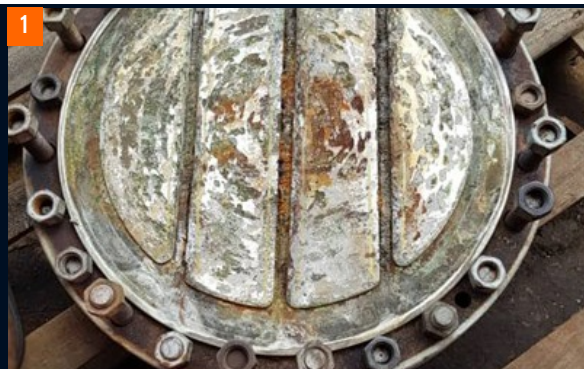
The flange and the cover of this exchanger were badly damaged by corrosion and needed to be rebuilt.

- 1- Cover before application
- 2- Flange before application
- 3- Flange after application
- 4- Cover after application

The substrate was first grit blasted to ensure a good mechanical bond with the product. Belzona 1111 was then used to rebuild the cover and the flange according to a modified version of Belzona System Leaflet HEX-02. Finally, the 2 parts of this equipment were machined back to the correct dimensions.
