# BELZONA RESTORES AND PROTECTS FLANGE FACE

ID: 7974

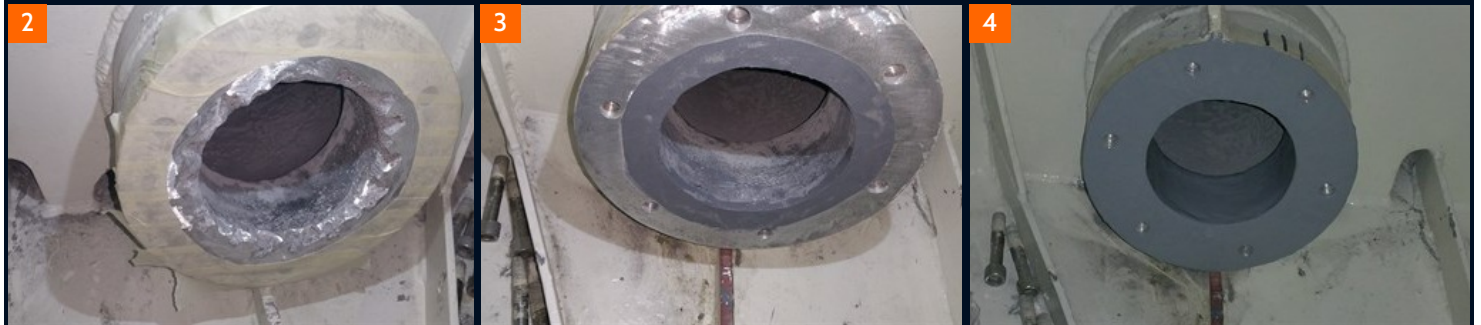
The problem here was that two different metals were situated next to each other causing heavy galvanic corrosion. The customer would have had to replace the whole system if he hadn't used the Belzona solution.

Flange face restored due to the effects of galvanic corrosion.

1. Flange before application
2. View after surface preparation
3. Flange face rebuilt with Belzona 1161
4. Flange fully restored and coated with Belzona 5831

A modified version of Belzona system leaflet VPF-13 was used to carry out this application. Surface preparation was carried out with an MBX bristle blaster, the flange face was reformed and built back up in various steps with Belzona 1161. Belzona 5831 was then used to coat the whole flange face to the preexisting internal tube.

Within 3 days the whole flange face was restored and was back in full working order, allowing for a quick return to service for the customer.
