# BELZONA ELASTOMER PROTECTS THE HAWSE PIPE ON A YACHT

ID: 7975

Protection of a hawse pipe on a yacht using the a Belzona elastomer.

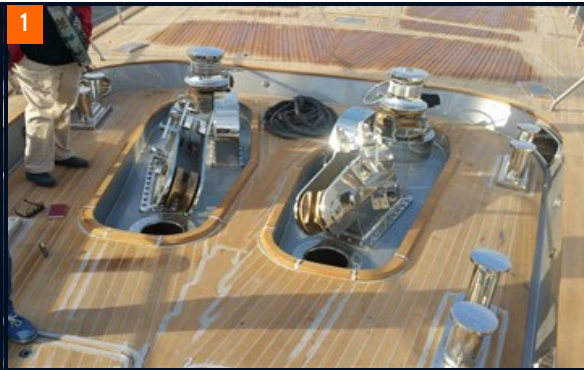
The internal hawse pipe was experiencing corrosion and also wear damage from when the chain would impact against the internal surface of the pipe.

1. View of the application zone
2. View of the external pipe before surface preparation
3. View of the internal hawse pipe after surface preparation with the MBX bristle blaster
4. Finished application with Belzona coatings applied
