# BELZONA SEALS HOTEL POOL DECK

ID: 798

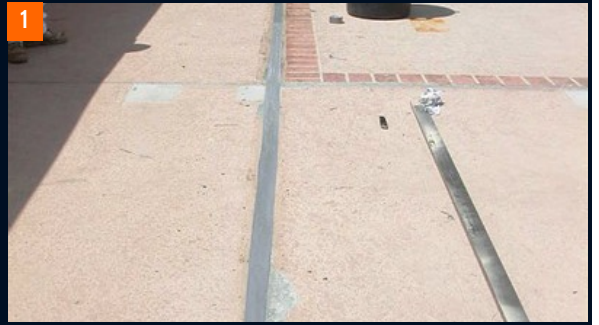
1. Stress cuts in concrete
2. Belzona 4111 with drain in place
3. Finished drain area
4. Finished pool deck

Belzona® 4111 applied to deck after careful preparation including levelling with a grinder. The drain covers were prepared and set in place with Belzona® 4111. Belzona® 3121 was used to seal stress cuts in the pad after they were cleaned, dried and prepared with a concrete grinder.
