# AHEAD OF TURNAROUND SCHEDULE WAS EASED UP WITH BELZONA HOT WRAP

ID: 7980

Process Water Stripper Column

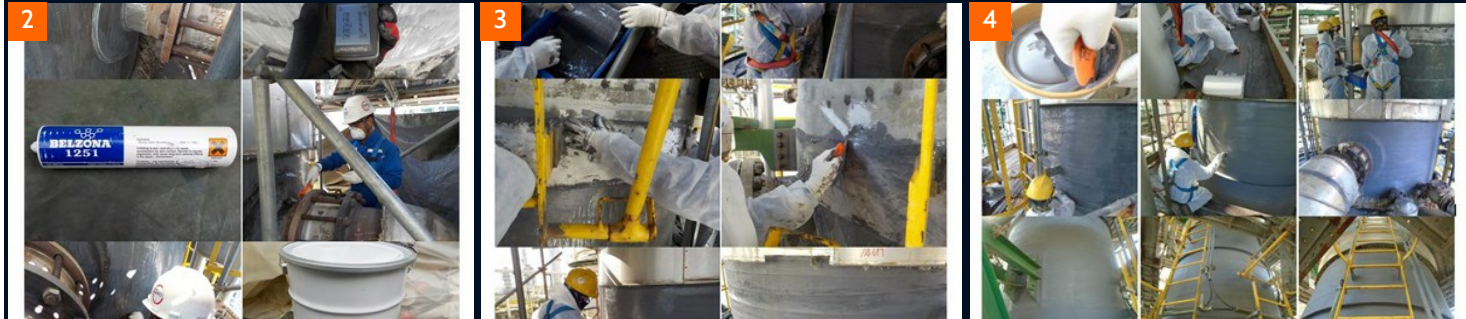
Internal corrosion of Process Water Stripper column caused lost wall thickness. Customer wanted to avoid unit shutdown for welding which would have meant total plant shutdown and the need to do it next year in major turnaround event, mid of 2020

1. Mock Up Test
2. Belzona 1251 Application
3. Belzona 9371 Application
4. Belzona 5851 Application

Due to the fact that we have to work on hot surface all the time, surface preparation by flap disc and pneumatic rotary grinding machine were allowed to use to remove all existing silicone base paint and most of inorganic ethyl zinc silicate. After that we used Belzona 1251 to smooth out weld seams and rim of nozzle reinforcement pads. Finally we applied two wraps (four layers) of Belzona 5851 together with Belzona 9371 around the target area Total application area 31 sq.m.
