# COATING INTERNAL SURFACE OF COOLING WATER PIPELINE

ID: 7981

Coating Internal Surface of Cooling Water Pipeine

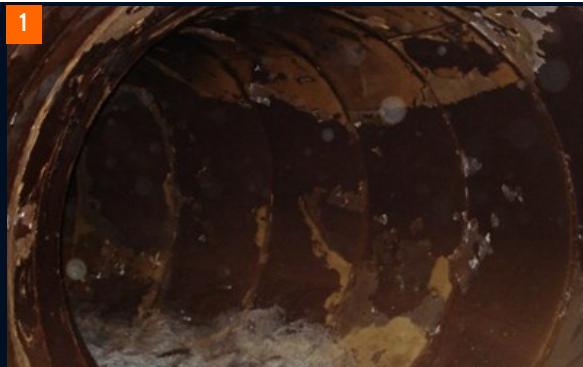
The cooling water (CW) pipe is the main focus for coating application due to failure of a previous coal tar epoxy coating on the internal surface of the pipe. The coal tar epoxy suffered from low adhesion and subsequently suffered from major blistering and peeling after three years. The customer was keen to find a high quality coating for long lasting service.

1. Internal Corrosion
2. 2 coats of Belzona 1341
3. 2 coats of Belzona 5811
4. Spark tested Spark test of Belzona 1341
