# BELZONA GIVES NEW LIFE TO FAN BLADES

ID: 7982

FRP fan blades in a petrochemical powerplant required rebuilding and coating

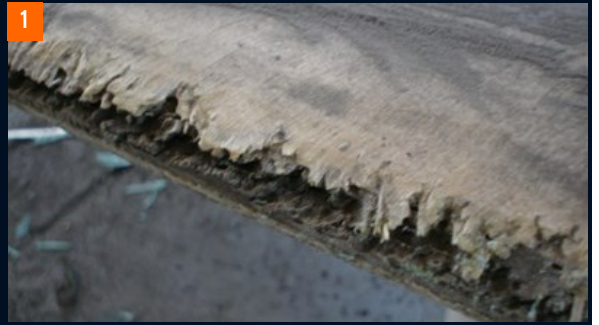
Deposit, erosion and mechanical damage of FRP fan blades for cooling tower were observed during turnaround period

Lead Edge Damage Surface Preparation using Power tools application of Belzona 5111 Application of SWII
