# BELZONA REPAIRS A RAW MILL IN A CEMENT INDUSTRY

ID: 7986

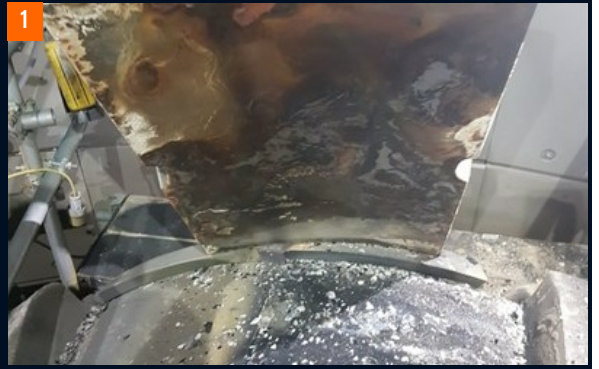
There are three rollers per mill and there are 12 wear plates (1200kg each) per roller. The clamps are fixed with 4 large bolts. There was play between the wear plate and the roller and the bolts and clamps were failing, leading to a forced stoppage of the mill.

- 1- Before application
- 2- After surface preparation
- 3- After application of Belzona 1111
- 4- Final application

The application was done in accordance with Belzona System Leaflet SHM-8. Two wear plates were removed from the roller at a time and the area on the roller was grit blasted. The back of the new wear plate was also grit blasted and Belzona 1111 was applied to the roller in a layer of approximately 2cm thick in the position corresponding to one wear plate. The wear plate was then fitted onto the wet Belzona 1111 to create a perfect seat. The process was repeated until 12 wear plates had been installed.
