# SEAWATER FILTER INLET AREA RESTORED WITH BELZONA

ID: 7988

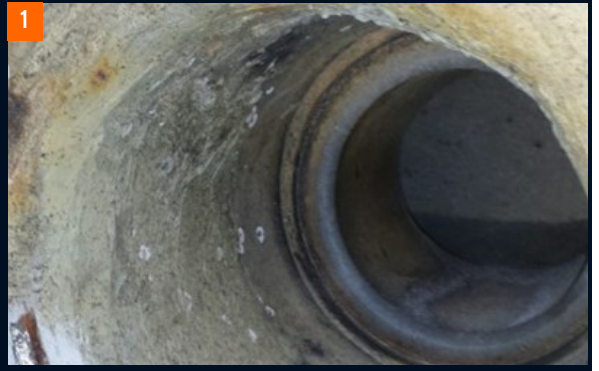
The area connecting the inlet area to the main section of the seawater filter is suffering from corrosion due to the presence of salts. In one of the defect areas, the damage has become through wall and started to leak. This puts additional strain on the seawater pumps to maintain the pressure of flow rate.

1. Corrosion on rim of inlet area
2. Through wall defect area prepared
3. Surface preparation on external surface
4. Completed repair
