# HIGH CHROME PUMP RESTORED WITH BELZONA

ID: 7993

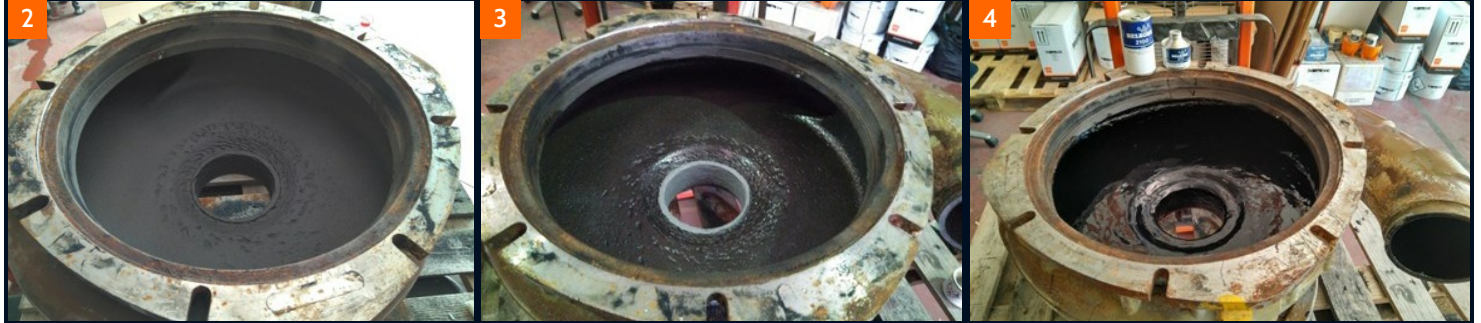
1. General view of equipment
2. Eroded internal casing
3. Belzona 2911 (Elastomer QD Conditioner) applied
4. Completed application

Despite the high hardness of the pump casing material, the high volume of solids in the process fluid has caused entrainment erosion.

A waste water pump made from a High Chrome Alloy material is used to carry water with a high concentration of suspended solids.

The surface was cleaned with water and detergent to remove residues and impurities. A non-ferrous, angular grit was used to grit blast the surface to a near white metal finish, and to achieve a rough profile. Belzona 2911 (Elastomer QD Conditioner) was applied to the surface and allowed to become touch dry. During the overcoating window, Belzona 2111 (D&A) High Build Elastomer) was applied. The application was carried out in accordance with a modified version of Belzona System Leaflet CEP-03.

Belzona 2111 (D&A High Build Elastomer) was selected to form a protective barrier for the internal surface from the effects of erosion. The high build nature of the material meant a thick layer could be applied to the surface for extended service life, reducing future maintenance requirements. The Belzona solution was a fraction of the cost of replacement.
