# BELZONA FLOOR REPAIRS AT FOOD MANUFACTURER

Deteriorated concrete floor in liquor make up area

Food Manufacturer in  
Northamptonshire, UK

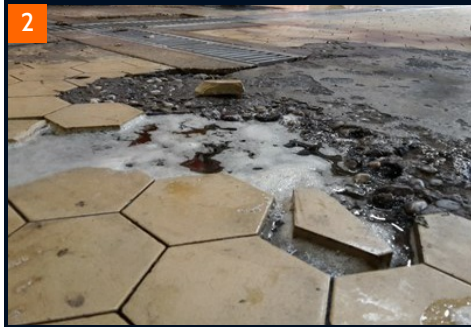
The customer had issues with the flooring where the tiles had started to lift and detach from the concrete substrate in a number of areas. The concrete was damp, wet and spalling in several areas.

1. Damaged concrete around drainage area
2. Extent of damage to floor with tiles removed
3. Belzona 4131 used to repair floor
4. Completed application

The area was cordoned off and the tiles removed to expose the concrete substrate. The surface was prepared using power tools to remove the loose concrete, tiles and to clean the corroded reinforcement. Belzona 4911 was applied prior to the application of Belzona 4131 using normal screeding techniques. A metal straight edge was then used to achieve a uniform thickness. Application was carried out in accordance with Belzona Know-How System Leaflet FPA-1.
