# BELZONA 1812 SAVES MAGNETIC WHEEL

ID: 7996

Restoring magnetic wheels in an ink factory.

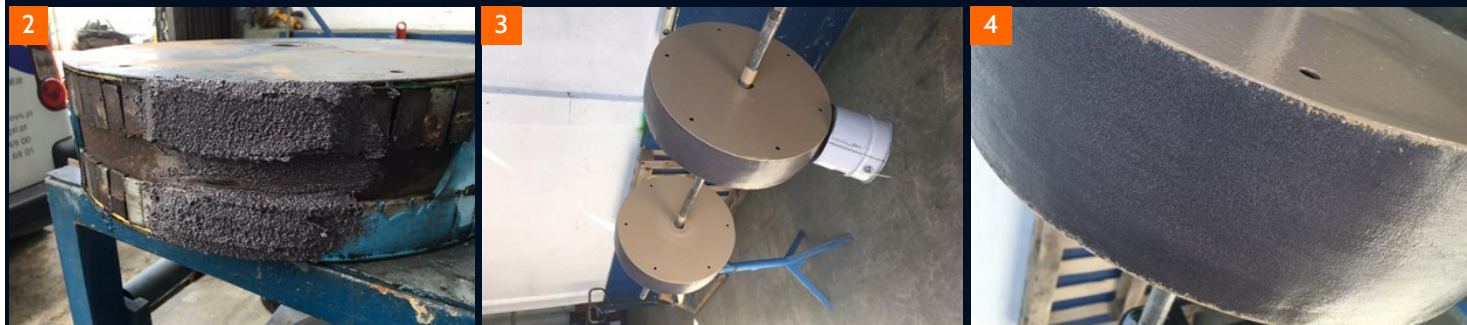
Previous polyurethane coating failed due to impact from magnetically transporting heavy cans of ink from one conveyor belt to another. The customer needed a better solution, Belzona 1812 was chosen to carry out the application.

1. Damaged magnetic wheel with existing polyurethane coating
2. Belzona 1812 being applied
3. Restored magnetic wheel showing it's magnetic capabilities
4. Finished application

The application was completed in accordance with an adapted version of Belzona System Leaflet SHM\_12. A test patch of Belzona 1812 was applied to the wheel to see if the magnets would still work covered with Belzona. A 4 kg tin can magnetically stuck to the wheel so the application went ahead. The previous polyurethane coating was removed and the steel was then blasted before reinstalling the magnets and applying Belzona 1812. Acetone was used to make the wheel look smooth and the sides were coated with Belzona 5811 for aesthetic purposes before delivering to the customer.

The magnetic wheel is still in great conditions with no problems nearly 3 years on.
