# BELZONA FILLS THE VACUUM

ID: 7997

A vacuum pump in a chemical plant carrying sulfuric acid at elevated temperatures.

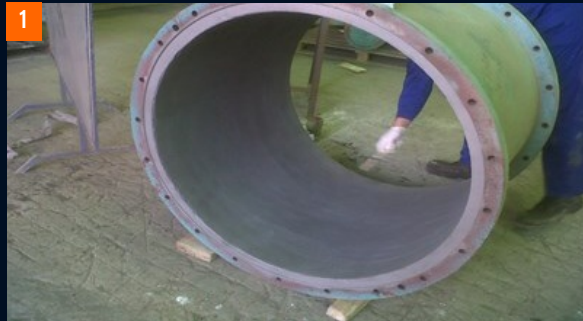
Due to chemical attack caused by the sulfuric acid at elevated temperatures, the pump has lost material on all components. As a result the tolerances no longer provide an effective vacuum and the pump is running at low efficiency.

1. Internal casing after preparation
2. Internal casing after coating
3. End covers coated
4. Impeller coated

After cleaning with a solvent degreaser to remove chemical residues, the surface was grit blasted to achieve a surface cleanliness in accordance with Swedish Standard SA 2.5 "Near White Metal". The entire internal surface, end covers, and impeller were coated with 2 layers of Belzona 4341. On the impeller tips, the coating was rebuilt to an excess of 5mm, then machined back to the required tolerances. The application was in accordance with a modified version of Belzona System Leaflet CEP-03 & CEP-07.
