# CORROSION PROTECTION ON FILTER CHAMBER PROTECTED WITH BELZONA

ID: 7999

Cement plant filter chamber

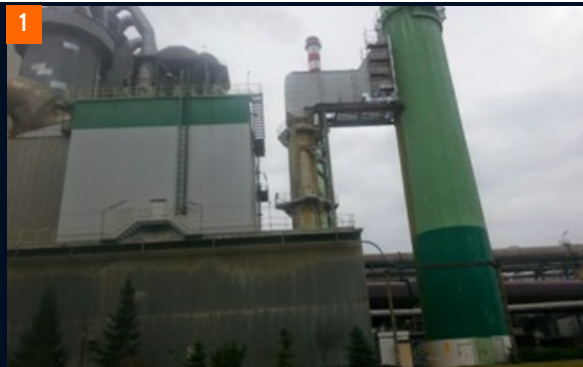
- 1 - The filter house
- 2 - Corrosion inside filter
- 3 - The completed job
- 4 - The completed job

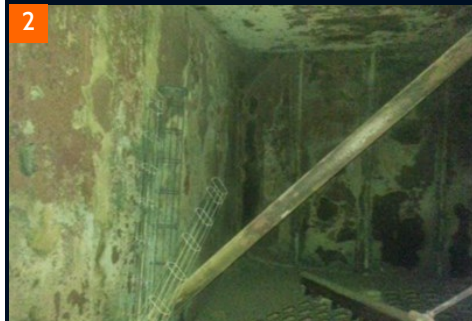
Hot gases had led to corrosion on internal surface of filter chamber. The rough surface caused by corrosion allowed a build up of dust on surface.

After grit blasting the steel to clean the surface and generate a surface profile, the coating was applied in accordance with Belzona system leaflet WPA\_2
