# BELZONA SEALS ACTIVE LEAK

36" Gate Valve holding back 27 miles of uphill diesel fuel.

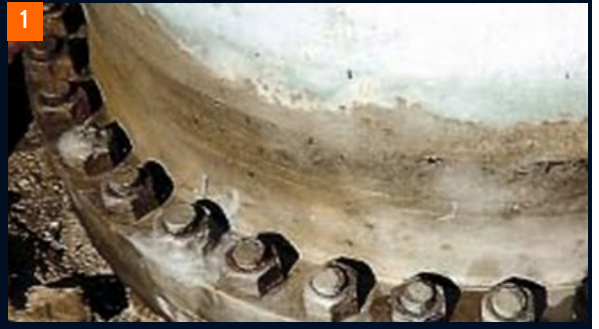
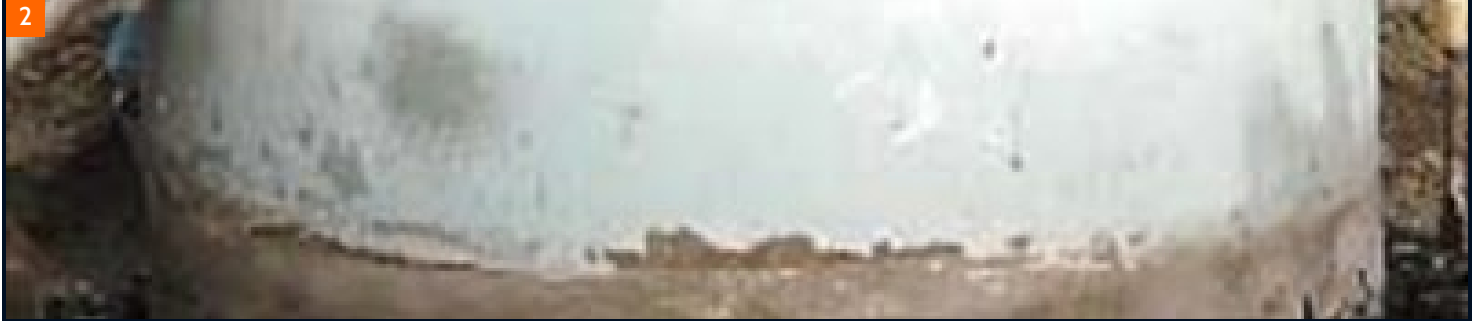
## PHOTOS

Fuel leaks at bolting areas between body and bonnet.

The application was carried out in accordance with a modified version of Belzona Know-How Leaflet GSS-3.

1. Surface cleaned and prepared.  
Belzona 1221 (Super E-Metal) is used to seal the active leaks.
2. All bolts and flange were coated entirely with Belzona 2131 (D&A Fluid Elastomer).
