# BELZONA SAVES A RUPTURED EFFLUENT TANK

ID: 8000

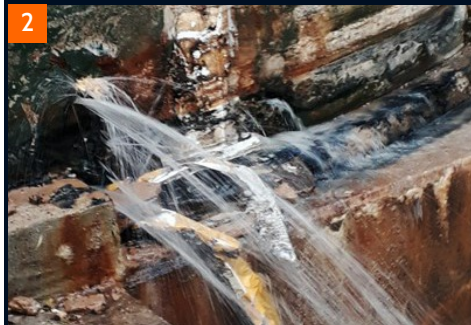
Leaking effluent treatment tank.

1. Effluent treatment tank
2. Extent of the leaks
3. Plates bonded over repaired areas
4. Sealed leaks around the base of tank

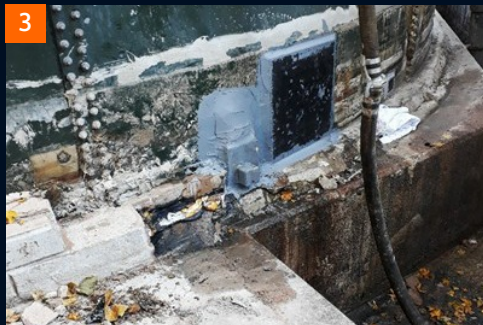
Corroded and through-wall defects on effluent tank created leaks in the system.

The leaks were plugged with wooden wedges to stem the flow. The areas around the leaks were then repaired with Belzona 9611 (ES-Metal). When the area was sealed, the wooden wedges were cut flush with the tank wall. They then bonded over the entire failed areas with Belzona 1111. Finally, when the Belzona 1111 had cured a bolt was screwed in, sealing the leaks. Belzona 1111 was also applied in a 75mm band around the base of the tank, incorporating reinforcing sheets, to seal the multiple leaks around the base. This was completed in accordance with Belzona system leaflet TCC-01.
