# BELZONA REPAIRS AND PROTECTS A CONCRETE CLARIFIER

ID: 8017

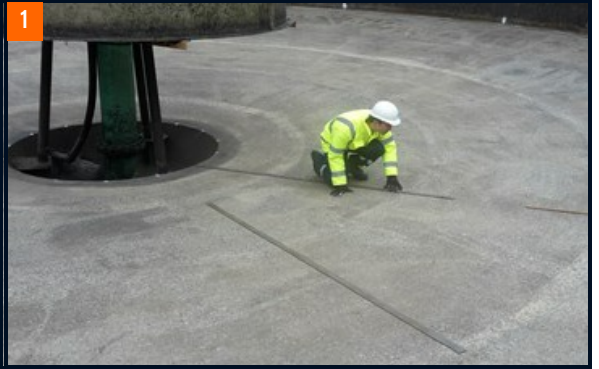
1. Placing screed rails
2. Belzona 4131 application by float
3. Application underway
4. The tank drained one year on

The application was carried out in accordance with a modified version of Belzona KNow-How System Leaflet FPA-1. The concrete was first power washed and prepared mechanically. The clarifier was marked out into sections. Each section was then conditioned with Belzona 4911 and then 6mm of Belzona 4131 applied.
