# BELZONA REPAIR TO TURBINE STATIONARY BLADE HOLDER

ID: 803

Stationary Blade Holder

Geothermal Power Station in Indonesia

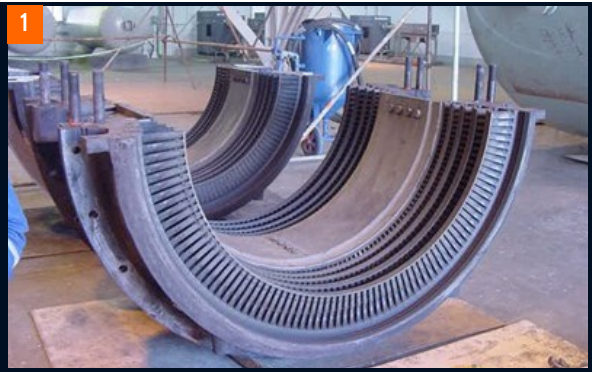
1. View of the Stationary Blade Holders
2. Typical damage found on the seating area after blasting
3. Template in place to form the Belzona 1111
4. Job completed with Belzona 1591

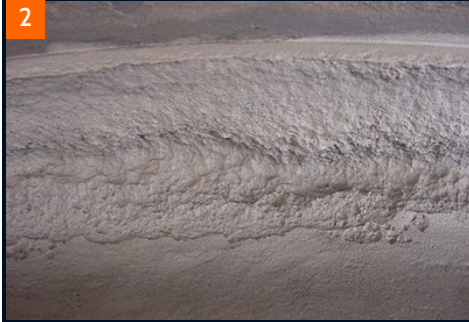
Erosion-corrosion on seating area of the upper and lower halves of the stationary blade holder. This had been caused by many years exposure to saturated steam.

Application was carried out in accordance with Belzona Know How System Leaflet CEP-3 and CEP-5.
