# BELZONA SEALS INSIDE TANK THE STEEL SHELL TO THE CONCRETE FLOOR

ID: 8030

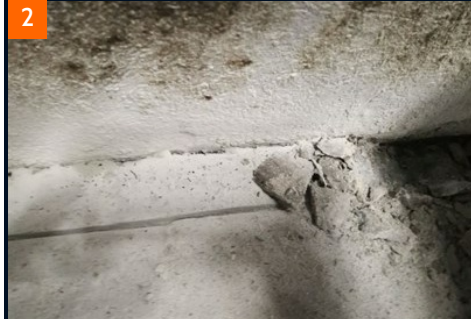
Between the concrete floor and the steel shell there was a gap of up to 6 mm that had to be sealed to stop the tank from leaking.

1. Initial view of the gap between the tank shell and the concrete bottom.
2. Surface preparation in progress.
3. NBR rubber cord forced into the gap
4. The finished application with Belzona 4111 applied on the left picture and the Belzona 1321 coating on the right picture.

In order to carry out the repair, the existing gap had to be enlarged, the contaminated concrete was removed, and the steel wall was cleaned and sandblasted, followed by degreasing the surface. In the existing gap a NBR rubber cord was inserted by force, and Belzona 4111 Magma Quartz was used to close the gap to the shell and restore the concrete thickness. The surface restored with Belzona 4111 Magma Quartz and the surrounding area on the steel shell where coated with a two coat system of Belzona 1321 Ceramic S-Metal, in order to provide corrosion protection.
