# BELZONA REPAIR TO TURBINE STATIONARY BLADE HOLDER CASING

ID: 804

## PROBLEM

Erosion-corrosion of the Turbine Casing, top and bottom seating area for the Stationary Blade Holder.

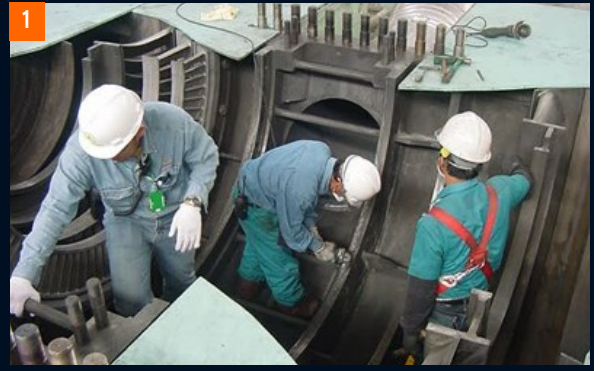
Steam Turbine Casing

1. View of Turbine Casing
2. Typical damage found on the seating area for the Stationary Blade Holder
3. Application of Belzona 1591 on seating area
4. Job completed with stationary blade holder installed in turbine casing
