# BELZONA REPAIRS CONDUCTOR CASING ON OFFSHORE PLATFORM

ID: 8045

Conductor casing on an offshore platform.

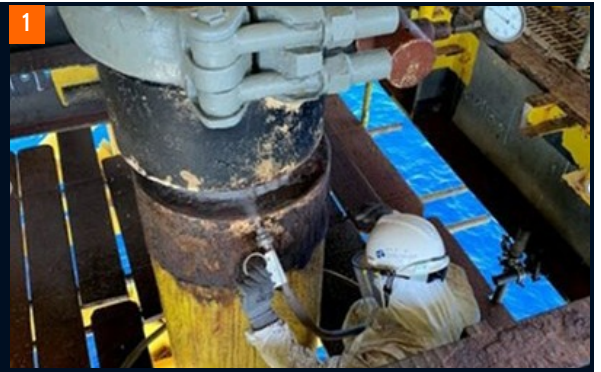
Surface preparation by blasting

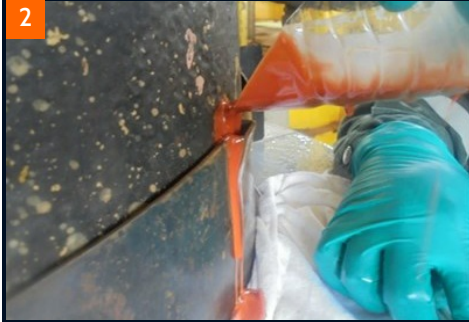
Pouring Belzona 7111

Belzona 7111 was poured to fill the void and was then sealed with Belzona 3411.

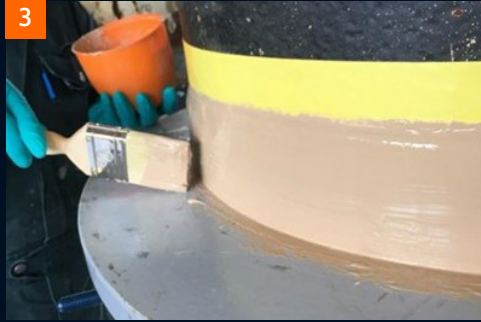
Sealing with Belzona 3411

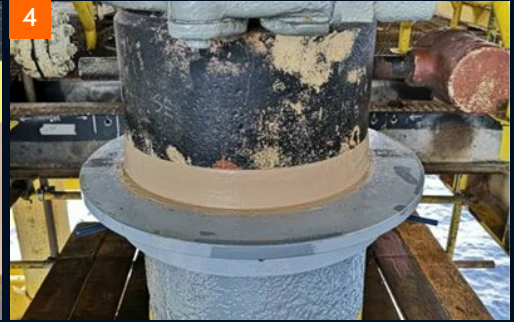
Finished Application
