# BELZONA COLD PLATE BONDING REINFORCES OFFSHORE WEATHER DECK

ID: 8046

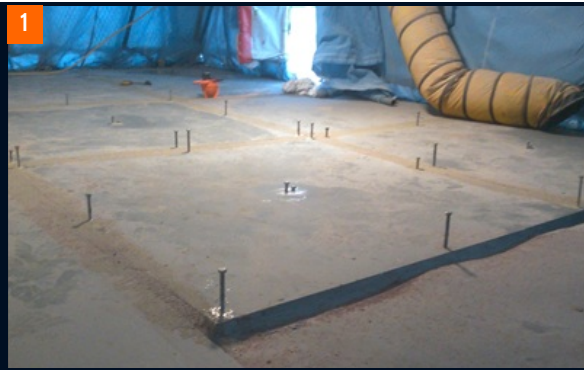
1. Positioning of Deck Plates.
2. Sealing of deck repair plates with Belzona 1111 (Super Metal)
3. Injecting Belzona 5811 (Immersion Grade) between repair plate and deck.
4. Completed application.

The application was carried out in accordance with a Belzona system Leaflet GSS-9 Creating Irregular Shims. All through wall holes on the deck were repaired and sealed with Belzona 1111 (Super Metal) Following gritblasting of manufactured steel plates (various sizes from 1x1metres to 1.6x1.6 metres) and weatherdeck, the plates were positioned and leveled using jacking bolts. The edges of the plates were sealed using Belzona 1111 (Super Metal). Belzona 5811 (Immersion Grade) was injected by single component airless spray into the crevice between the existing deck and reinforcement plate.
