# BELZONA HELPS IN THE RESTORATION OF AN IRRIGATION PIPELINE

ID: 8049

Restoring an old irrigation pipeline within a pumping station.

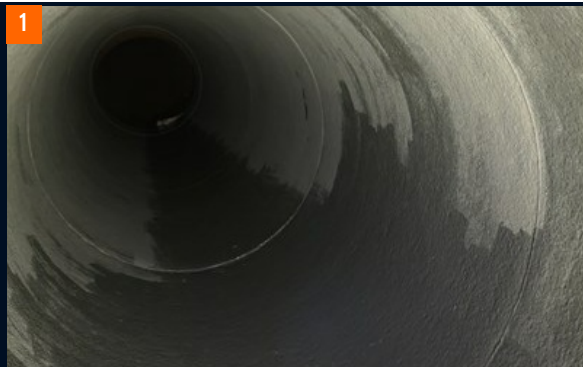
1. View after sandblasting
2. Application of Belzona 1121
3. Application of Belzona 1982/9381
4. Application of Belzona 5821

This application was carried out in accordance with system leaflet TCC-05. The internal walls of the pipeline were sandblasted and then any pitted areas were filled in with Belzona 1121. A Belzona SW2 system was then fabricated to create a "pipe within a pipe" to restore the existing pipeline. Finally 2 coats of Belzona 5821 was applied over the SW2 system to provide corrosion and erosion resistance.
