# BELZONA COLD PLATE BONDING REPAIRS & REINFORCES SILOS

ID: 8050

Mining: Corrosion repairs needed to 8 x Nickel Storage Silos.

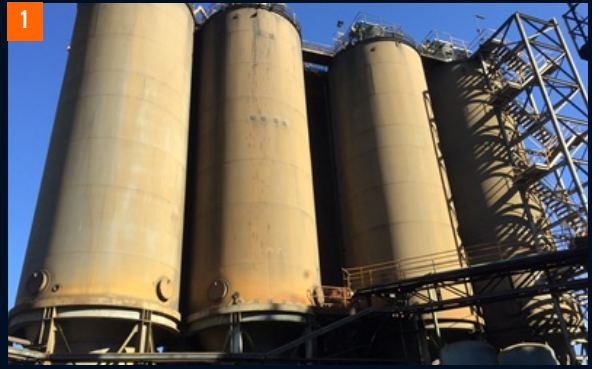
1. The 8 x Nickel Storage Silos
2. Pitted and corroded Silo wall.
3. Plates in place going around the Silo.
4. Completed application.

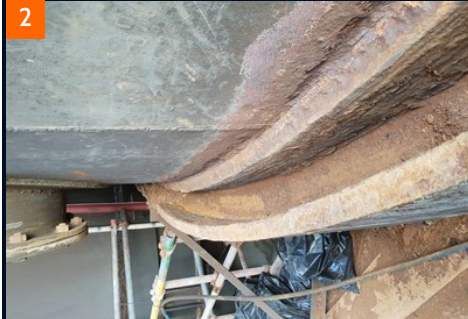
Inspections were carried out on the Silos and they were found to have severe corrosion loss to bottom sections of all Silos. To empty each Silo would have been a major cost and because the Silos are internally coated welding was not an option.

The application was carried out by Cold Bonding 200mm x 1m rolled plates with Belzona in accordance with the Method Statement for Cold Plate Bonding. After abrasive blasting, all corrosion holes were first repaired by filling with Belzona 1111. Belzona 1111 was then applied to the plates which were bonded into place. Belzona 1121 was used when temperatures rose above 35 C to allow more working time.
