# RECONSTRUCTION OF A CONCRETE TANK IN THE PRE-TREATMENT PLANT USING BELZONA

ID: 8053

Reconstruction of defects and chemical protection of the concrete tank in the pre-treatment plant.

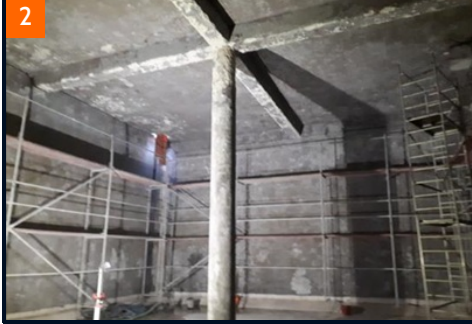
Destruction of the existing chemical resistant coating and significant losses in the tank ceiling beams. Degradation of the coating by chemically aggressive wastewater and their vapors. Cavities and cracks in the concrete walls and ceiling of the tank. Chemical corrosion of concrete resulting in weakening of floor beams.

1. Treatment Plant
2. Treatment Plant Problem
3. Treatment Plant Application
4. Treatment Plant Complete with Belzona 4111 & Belzona 4311
