# CHEMICAL PROTECTION OF A SEDIMENT TANK

ID: 8054

Chemical protection of the sediment tank and reinforcement in the sewage treatment plant with Belzona composite materials.

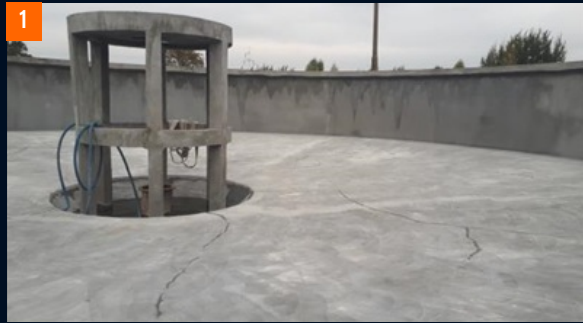
The accumulation of sediment on the bottom and walls of the tank. The penetration of aggressive dirt into the depths of concrete, chemical corrosion of concrete and damage to concrete walls of the tank and cracking at the bottom.

1. Chemical Protection
2. Spraying Picture
3. Applying Picture
4. Application Complete

The application was completed in accordance with Belzona System Leaflet TCC-15. High pressure washing, blast-cleaning and vacuum cleaning of the interior of the entire tank. Surface activation and re-profiling of the side wall defects and cracking of the sediment bottom with the Belzona 4111. Applying two layers of the Belzona 5821 coating by airless spraying.
