# STRENGTHENING OF A STORAGE TANK WITH BELZONA SUPERWRAP II

ID: 8055

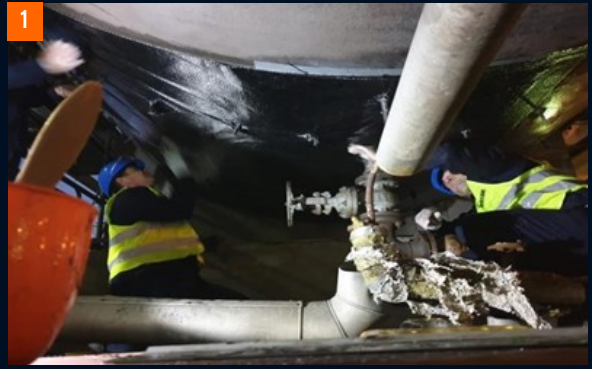
1. Belzona 9381 Superwrap II Applied
2. Belzona 9382 - Release Film Applied
3. Belzona 9382 - Release Film Applied
4. Belzona Superwrap II Complete

The application was completed in accordance with Belzona System Leaflet VPF-11. The substrate was prepared and degreased. Belzona 9381 Reinforcement Sheet was wet out with the Belzona 1981 resins as well as the substrate. Belzona 9382 was applied to consolidate the repair.
