# HYDROELECTRIC GENERATING STATION SCROLL TUNNEL

ID: 8056

Refurbishment of a Hydro electric Generating Station to allow the facility to be brought back online.

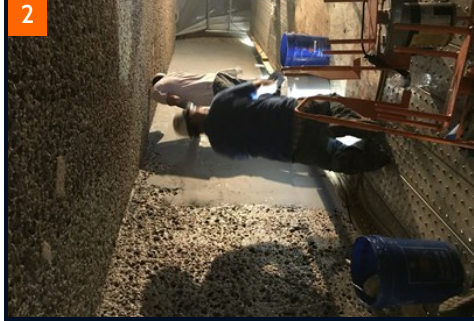
The concrete scroll tunnel walls, floor, and ceiling were deteriorating due to many years of operation. Total area to be treated was 9000 sq. ft. Belzona 4141 lightweight Magma Build was used to restore the ceilings up to 2" thick in areas. The walls and floor were repaired with Belzona 4131 Magma Screed. After restoring the concrete, Belzona 5811 immersion grade barrier coating was used to protect the entire area.

1. Concrete deterioration
2. Rebuilding concrete with Belzona 4131
3. Tunnel coated with Belzona 5811
4. Finished results
