# BELZONA PROTECTS LP FLARE DRUM

ID: 806

## PROBLEM

Failure of existing Glass Flake lining, leading to corrosion

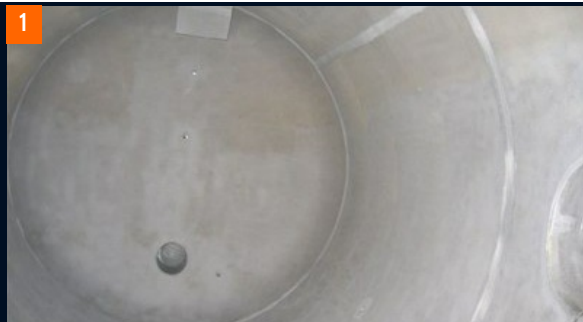
1. Blast preparation and stripe coat complete.
2. Spray application and repairs complete.
3. Inspection after 12 months service.
4. LP Flare drum in service.

Belzona® 1521 was applied in accordance with a modified Belzona Know-How System Leaflet TCC-5.

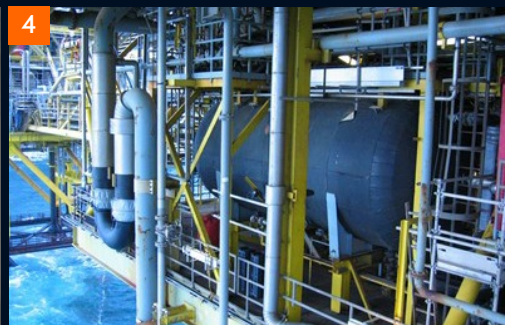
Low Pressure Flare Drum with Design conditions  $-46^{\circ}\text{C}/+99^{\circ}\text{C}$  and 5 bar pressure.
