# BELZONA CHOCKING REPAIR ON GEAR MOUNTING

ID: 8061

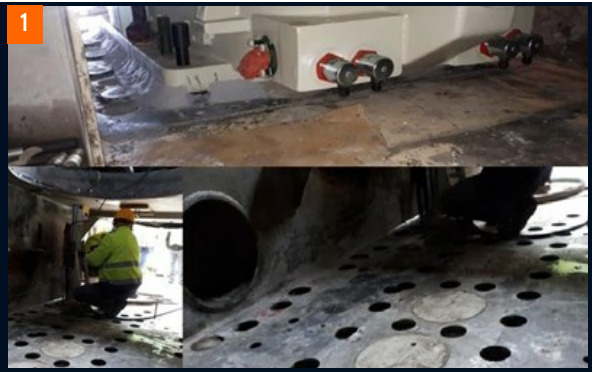
Gear mounting not working at full efficiency due to misalignment.  
Repair work need to concrete area prior to chocking.

1. Gear Equipment Picture
2. Application of Belzona 4111
3. Application of Belzona 7111
4. Chocking application complete.
