# BELZONA KEEPS THE HOSE FLOATING

ID: 8065

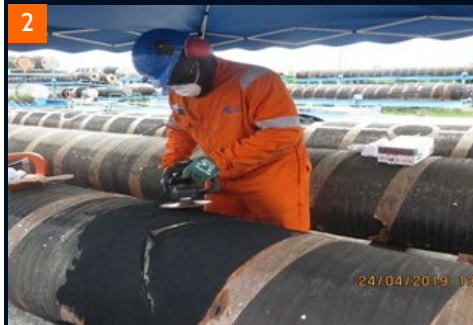
The offloading hose used to carry petroleum products from offshore to the shore had cuts caused by debris in the sea, contact with passing boats and marine life.

Surface cuts of floating hoses. The hoses have been brought out of the water into a courtyard for repair due to the damage.

1. Damaged Area
2. Surface Preparation
3. Degreasing & removing debris
4. Completed repair
