# BELZONA REBUILDS AND PROTECTS OIL TANK

ID: 8067

Crude oil storage tank.

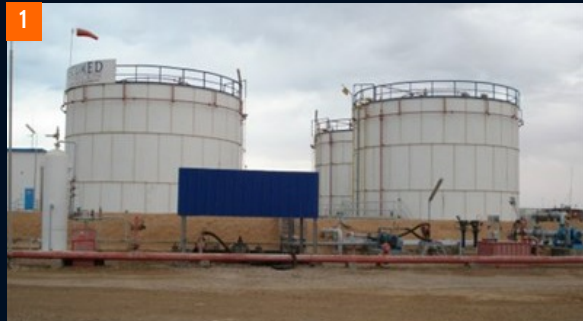
1. External view of the storage tank
2. Pitting at the base of the tank
3. Belzona 1121 plate bonding
4. Internal coating of Belzona 5811

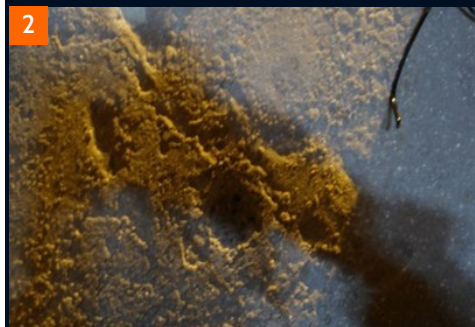
Severe pitting was present at the base and lower section of the tank wall, this was a result of a mixture of water and also hydrocarbons found within the crude oil. As the density of the water is greater than the hydrocarbons, the water will sit at the bottom of the tank causing corrosion in this lower section of the tank.

Belzona 1121 was used to fill in the pits of the localized damaged areas and plate bonding was used to restore any larger damaged areas on the base of the tank. Once the structure of the tank had been restored, 2 coats of Belzona 5811 were applied to the lower section of the tank.
