# BELZONA MAGMA FOUNDATIONS REPAIR AT CEMENT FACTORY

ID: 8070

Repair of the foundations of the clinker furnace head at a large cement factory in Poland.

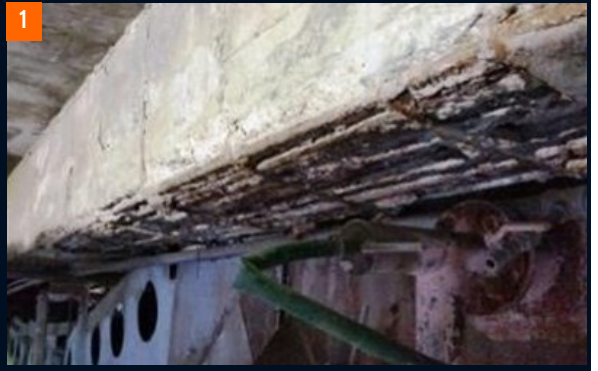
During long-term operation under varying climatic conditions and high temperatures, the foundation (supports, beams) was degraded under the head of the clinker furnace.

1. Degraded Concrete
2. Metal Mould to pour Belzona 4111
3. Applying Belzona 4111
4. Finished Job.

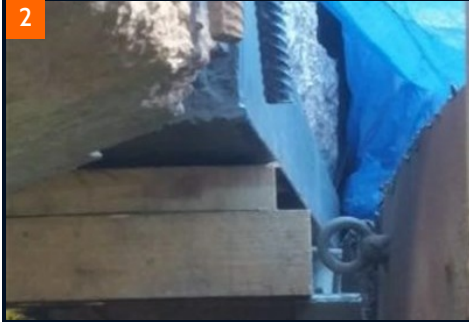
The application was completed in accordance with an adapted version of Belzona System Leaflet WPA-4. A metal mould was created around the affected area to pour the Belzona 4111 into to ensure a perfect finish.
