# TURBINE RESTORED AND PROTECTED WITH BELZONA

ID: 8071

Repair of a turbine suffering from corrosion and erosion.

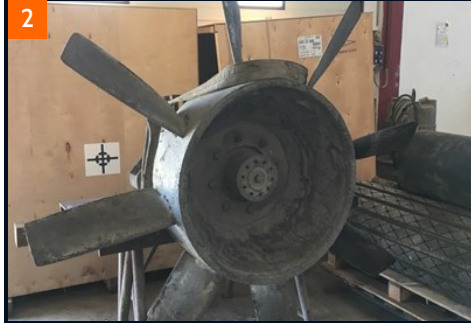
1. Overview of the blower
2. Eroded-corrode turbine
3. Belzona 1331 being applied to the turbine
4. blower back in service

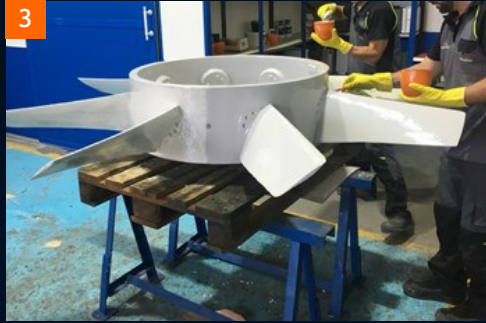
General erosion-corrosion on the turbine of a blower used as part of copper mining process. The erosion had caused a loss of material which could result in balancing issues.

Application carried out in accordance with Belzona Know-How System leaflet FBC-01 & FBC-02. The turbine was grit blasted down to SA 2.5 and then the lost structure was rebuilt with Belzona 1311. Finally 2 coats of Belzona 1331 was applied to prevent further corrosion-erosion.
