# CORROSION PROTECTION 2 X INDUSTRIAL STORAGE TANKS WITH BELZONA 5811

ID: 8073

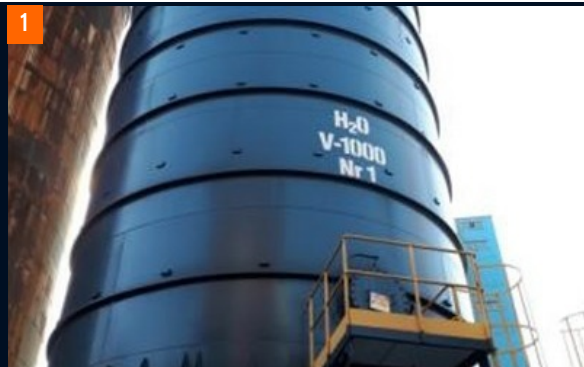
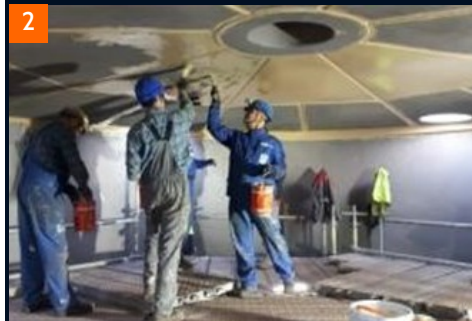
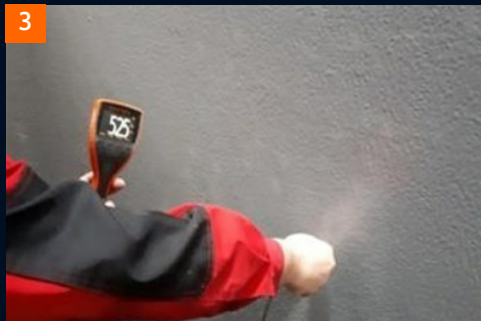
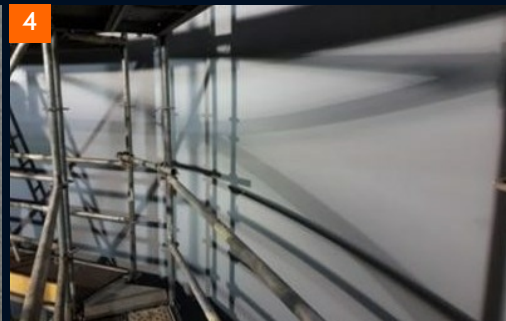
Corrosion on the internal linings of two large storage tanks at a large industrial plant in Poland.

1. One of the storage tanks to be coated.
2. Belzona 5811 applied internally.
3. Testing dry film thickness.
4. Application complete on the internal lining.

Corrosion protection for 2 DEMI water tanks (Total area - 1520 m<sup>2</sup>, 2000m<sup>3</sup>)

The application of Belzona 5811 was completed in accordance with Belzona System Leaflet TCC-5.
