# BELZONA SECURES A LIFTING WINCH

ID: 8075

Lifting winch being secured on the deck of a dredging vessel

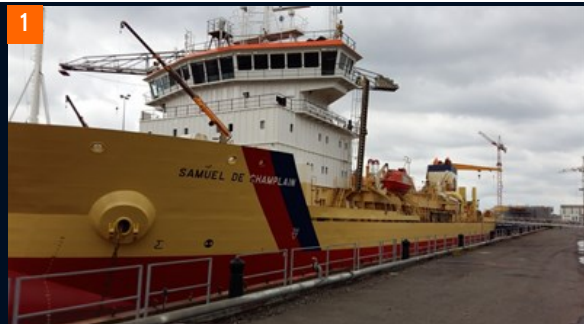
1. Dredging vessel
2. Area marked and damned, ready for application
3. Pouring in progress
4. Completed application

The 4 supporting pads were chocked using Belzona 7111 in order to ensure optimum load transmission as well as long term protection against vibration. The fast curing properties of the material were a key factor for the operator of the ship.
