# BELZONA PROTECT NEW WATER DISTRIBUTION PIPEWORK

ID: 8079

Protection against corrosion / erosion on new sections of pipework

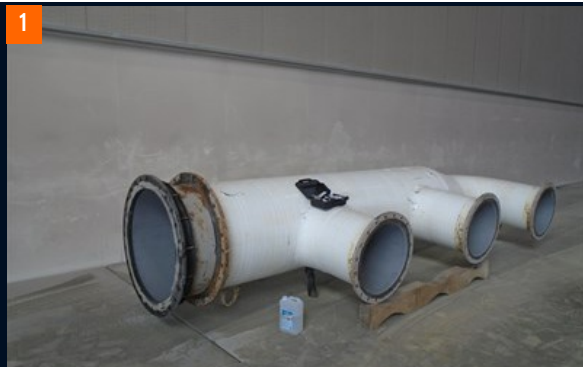
New pipework system, 300m<sup>2</sup> in total (including 4 large pipework sections, 52 bends and 5 tees)

- 1- Section of pipework (4 in total)
- 2- Application of Belzona 5821 completed
- 3- Inspection in progress

Hand application of Belzona 5821 followed by a thorough inspection to ensure that the application was carried out as per the Instructions For Use.
