# BELZONA REPAIRS GEAR BOX OF DREDGER

ID: 808

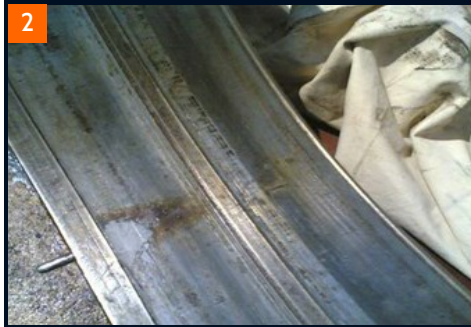
Gear Box of dredger cutter shaft.

1. View of the dredger cutter shaft gear box
2. Worn out bearing housing
3. Form was applied, then Belzona injected through the former
4. Gear box bearing housing perfectly rebuilt

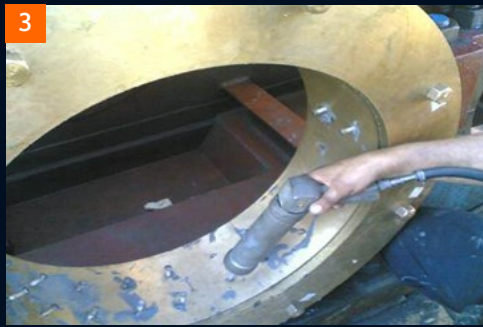
Bearing housing of the gear box was badly worn due to bearing failure.
