# BELZONA 5721 PROTECTS WIND TURBINE BLADES' LEADING EDGES IN A SINGLE COAT

ID: 8084

At a UK wind farm, one of the Endurance E-3120 turbines was undergoing maintenance and inspection, specifically to the wind turbine blades.

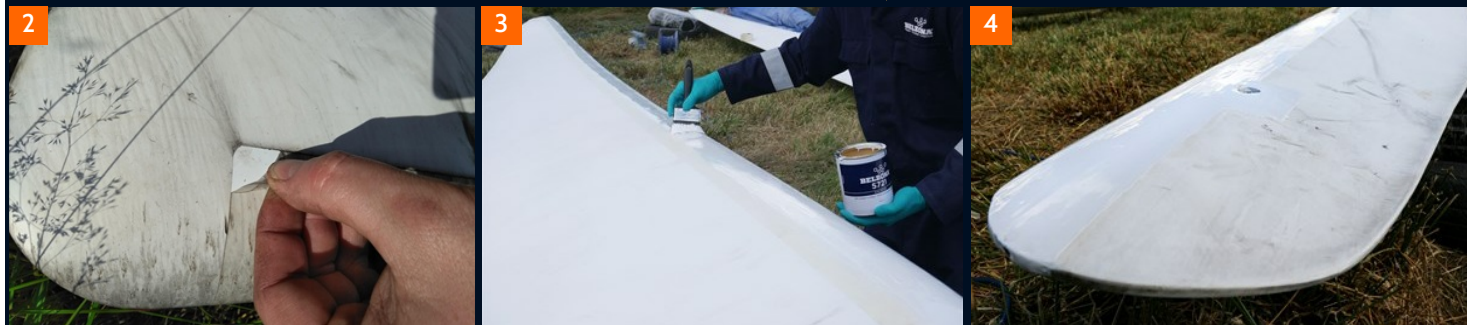
The wind turbine blades were suffering from damage due to rain erosion and from mechanical lifting of the blades. The existing tape system had begun to peel in patches, as well as some noticeable areas of erosion and impact damage present through the tape.

1. Blades taken down from the turbine before cleaning
2. Existing tape system had started to peel
3. After preparation, Belzona 5721 was applied to the leading edge
4. Finished LEP application

The blades were removed by the asset owner for inspection and general cleaning, before the existing tape system was removed. Positioned on stands at 45°, the area to be coated was masked off and sanded using an orbital sander and then cleaned of any debris. Belzona 5721 was mixed and applied by brush to a band of 20cm (8") around the leading edge in a single coat. Finally, the masking tape was removed before the coating could fully cure.
